PARRAMATTA LIGHT RAIL

PLR-SOM Noise and Vibration Monitoring Report

January 2023

PLR1SOM-GLR-ALL-NV-RPT-000001 Rev A Version 01

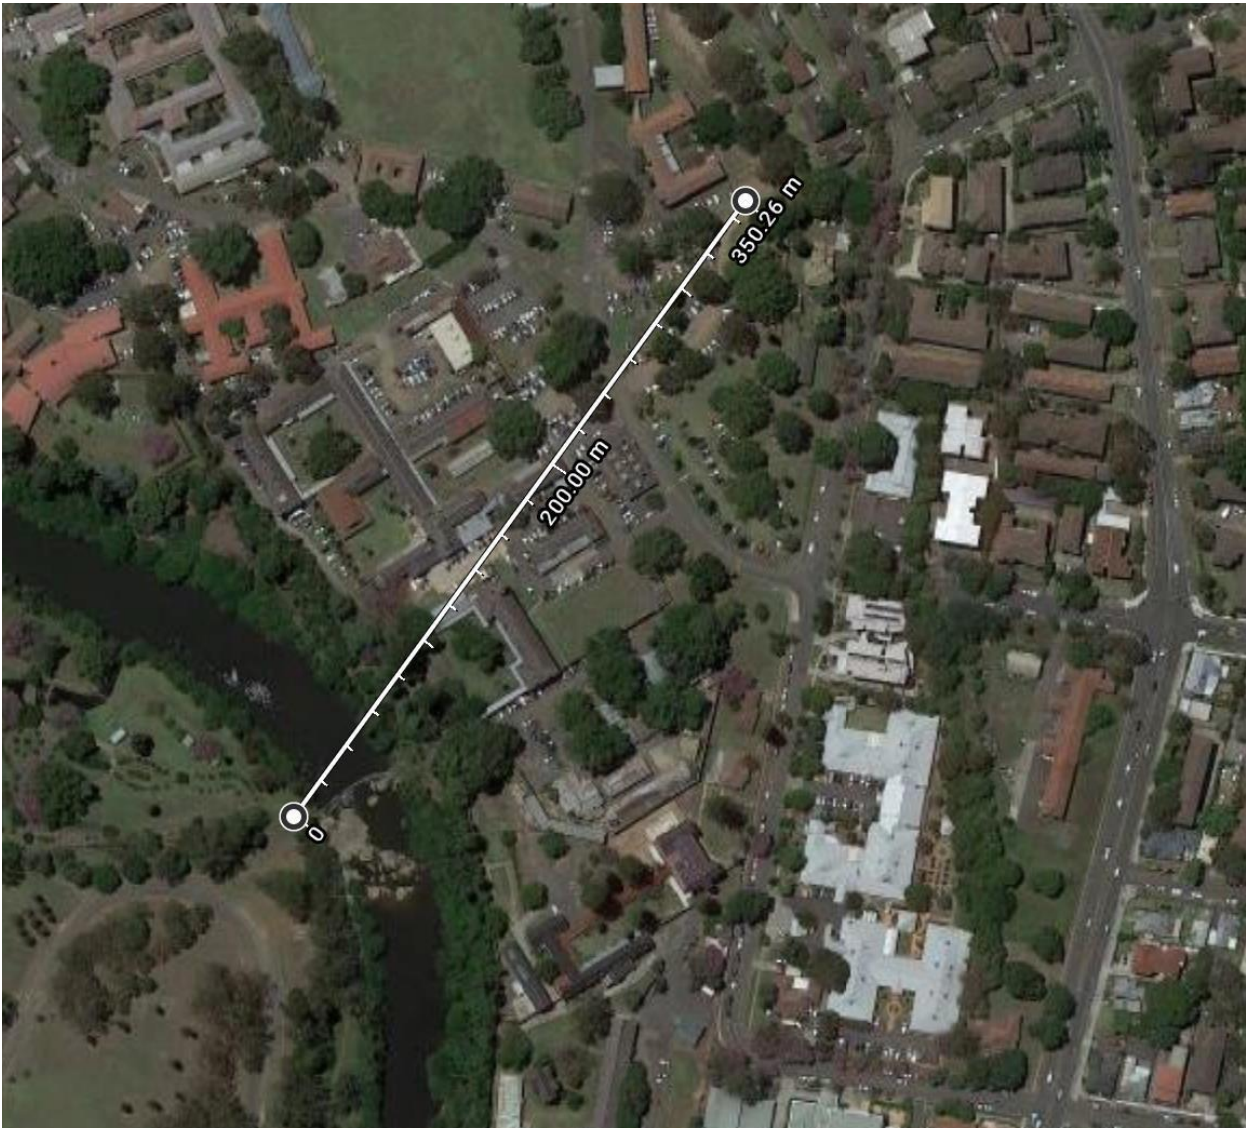
Monitoring/observation location (marked as "0"), showing the distance to the Ngara stop works. The trees directly north of the monitoring location were considered the nearest flying-foxes to the works.

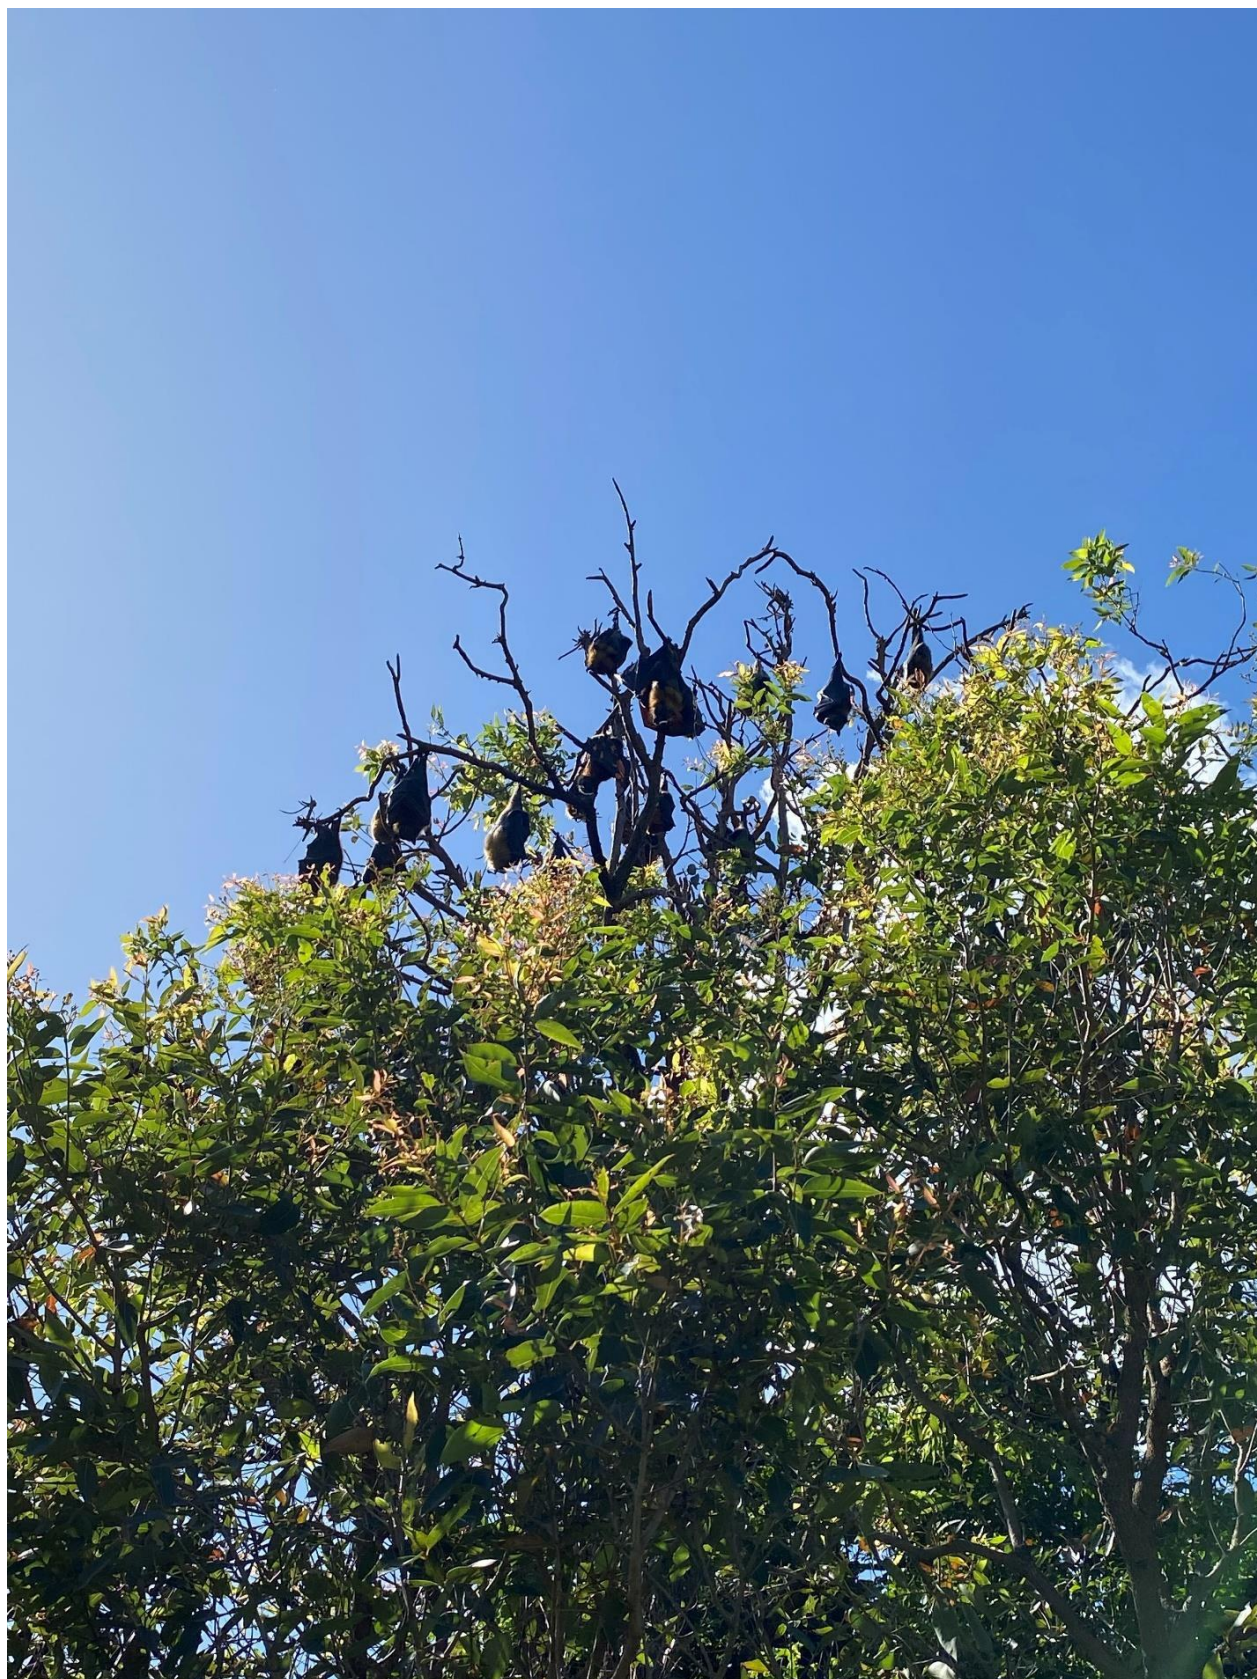
Figure 1: Flying-foxes roosting during session. Photo taken at 08:57.

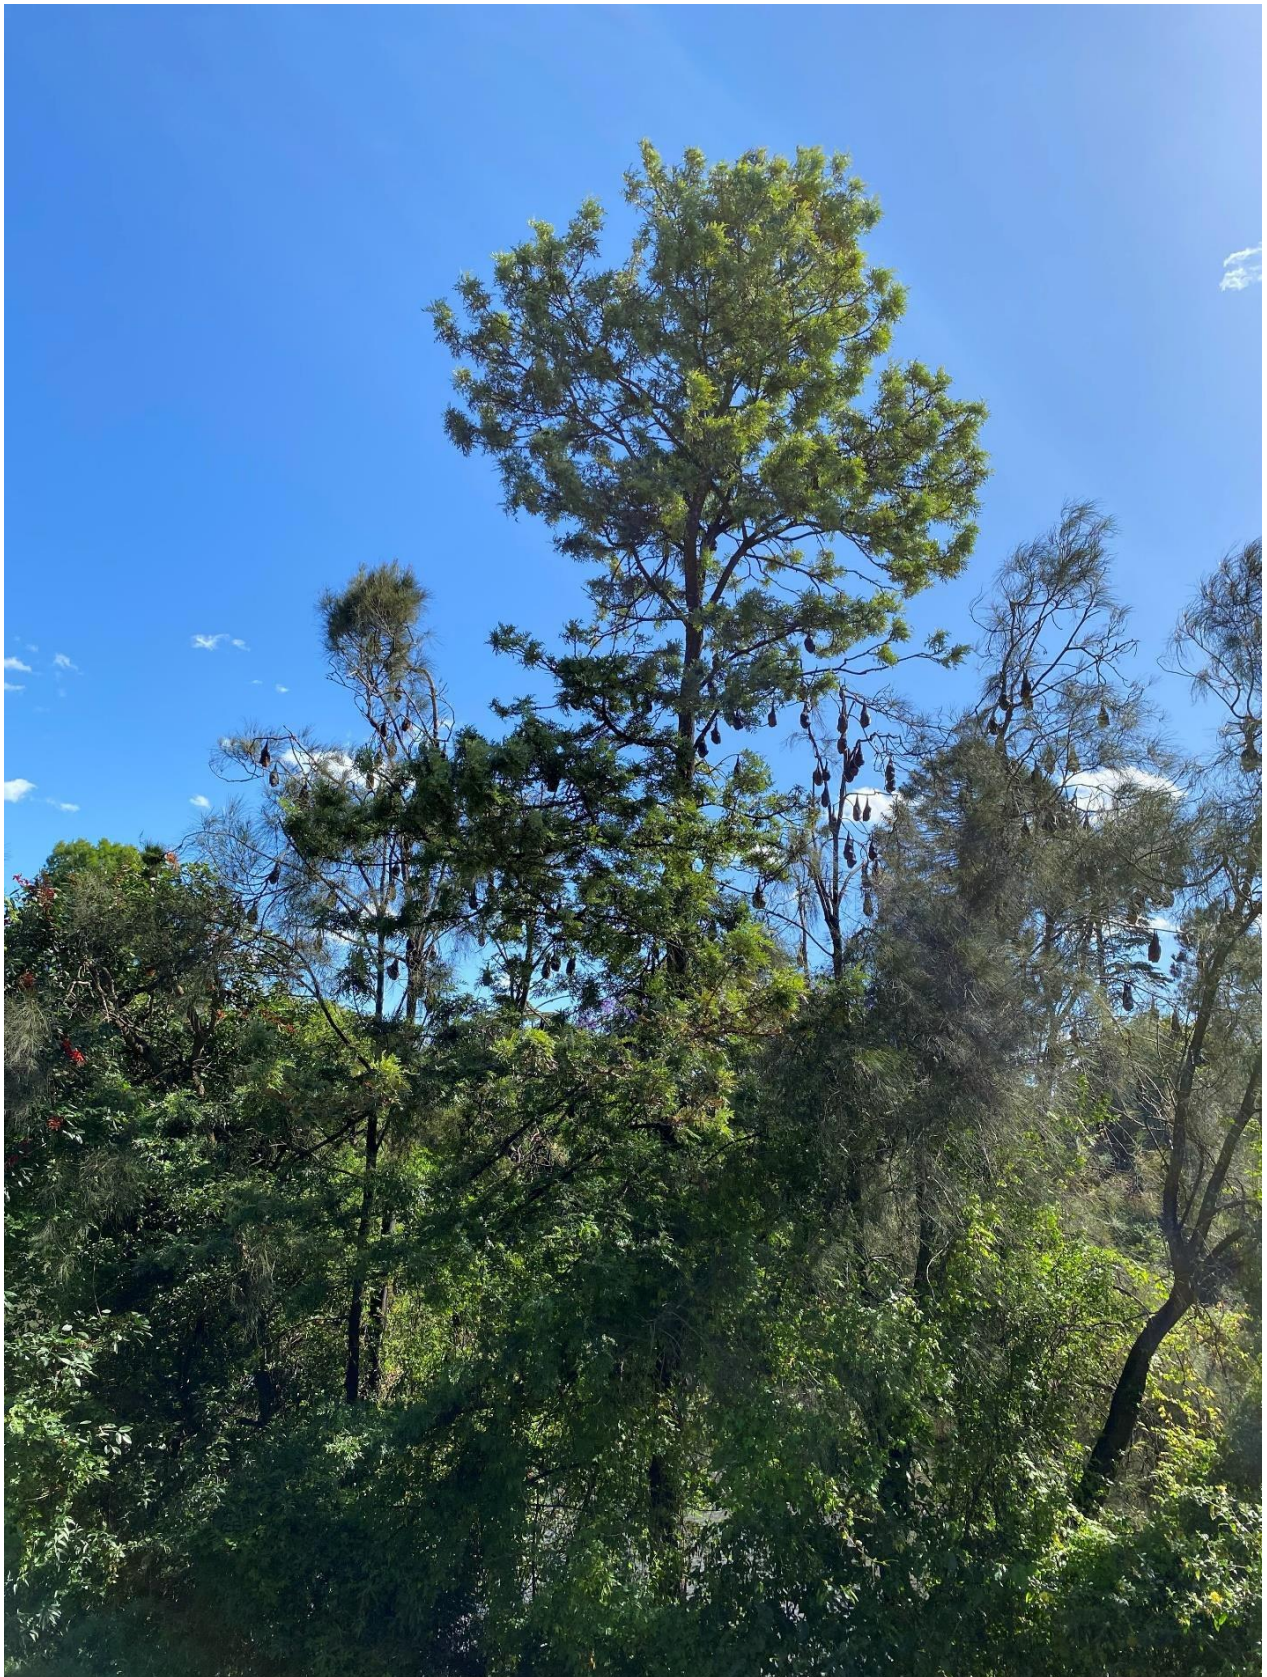
Figure 2: Flying-foxes roosting during session. Photo taken at 09:32.

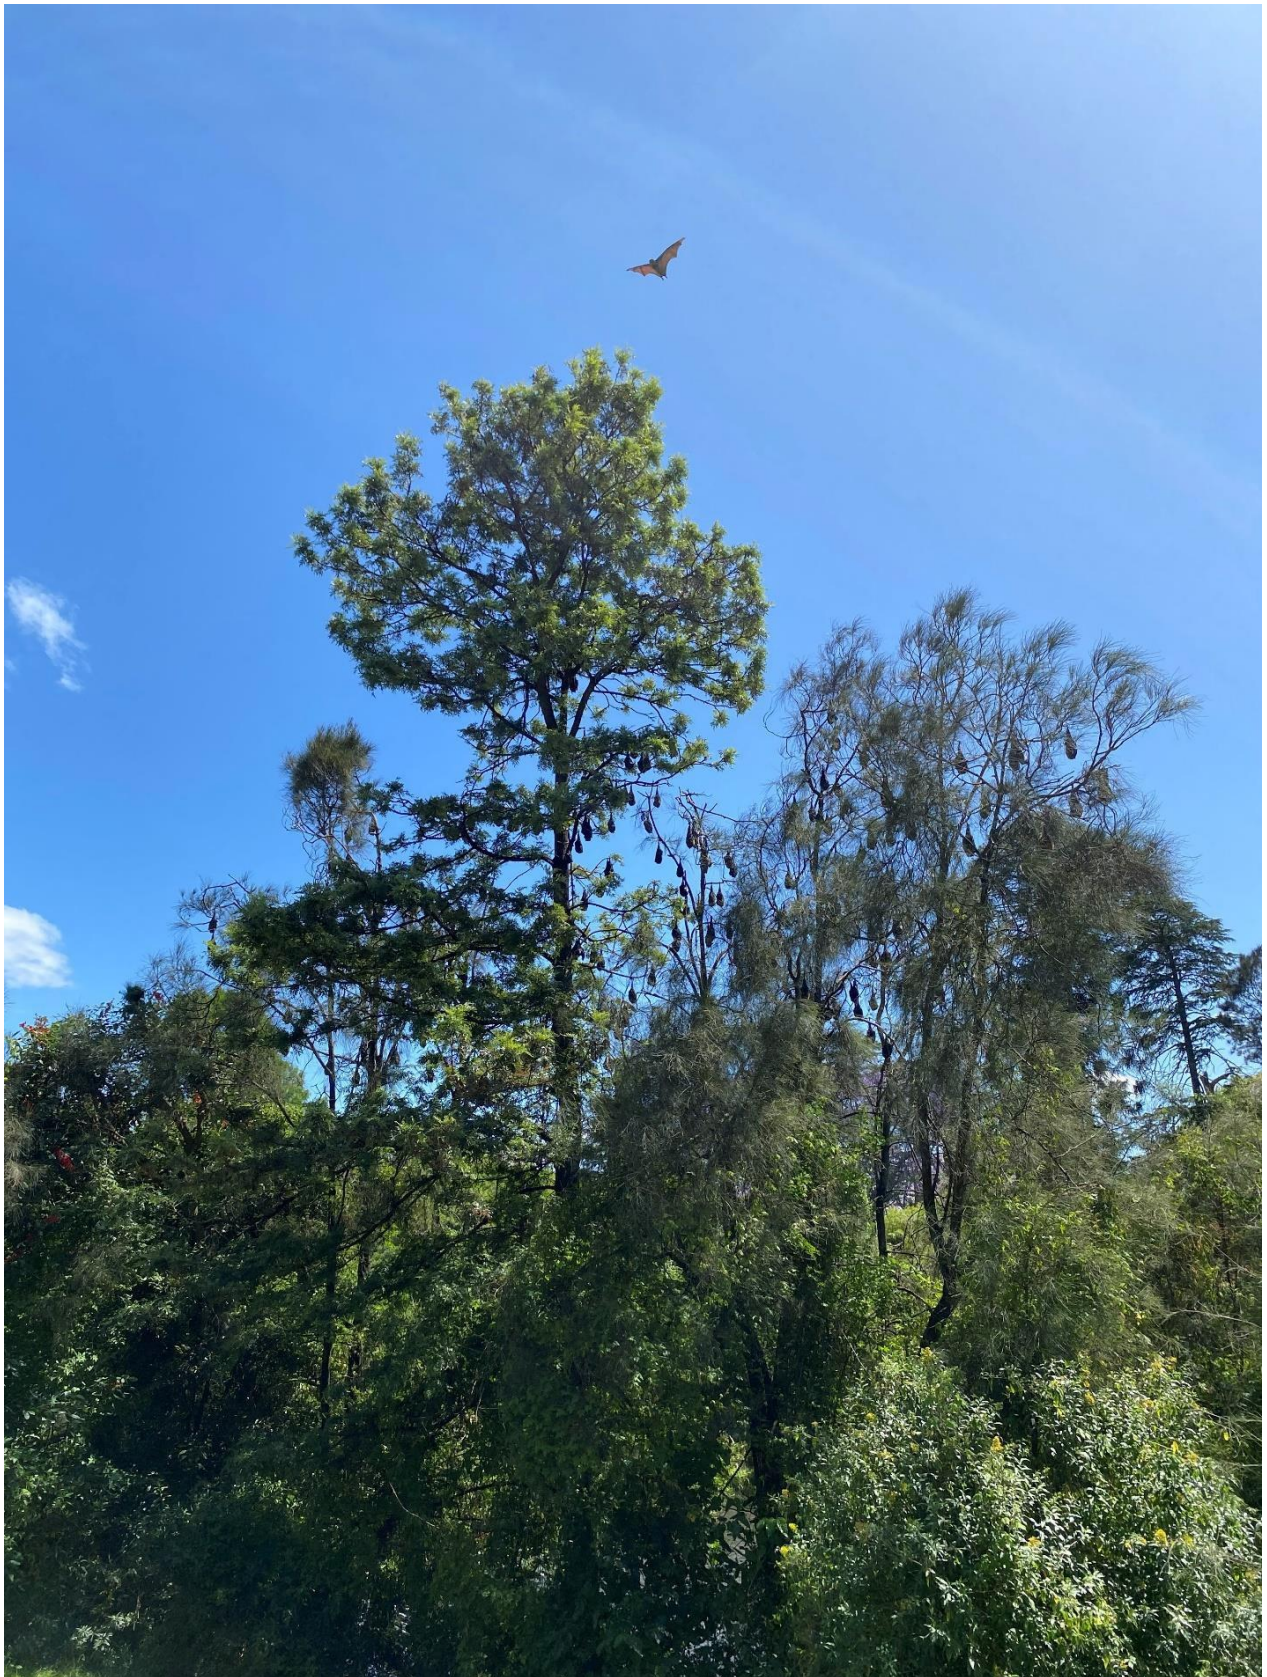
Figure 3: Flying-foxes roosting during session. Approx. 20 flying-foxes returned to roost during the session. Photo taken at 10:40.

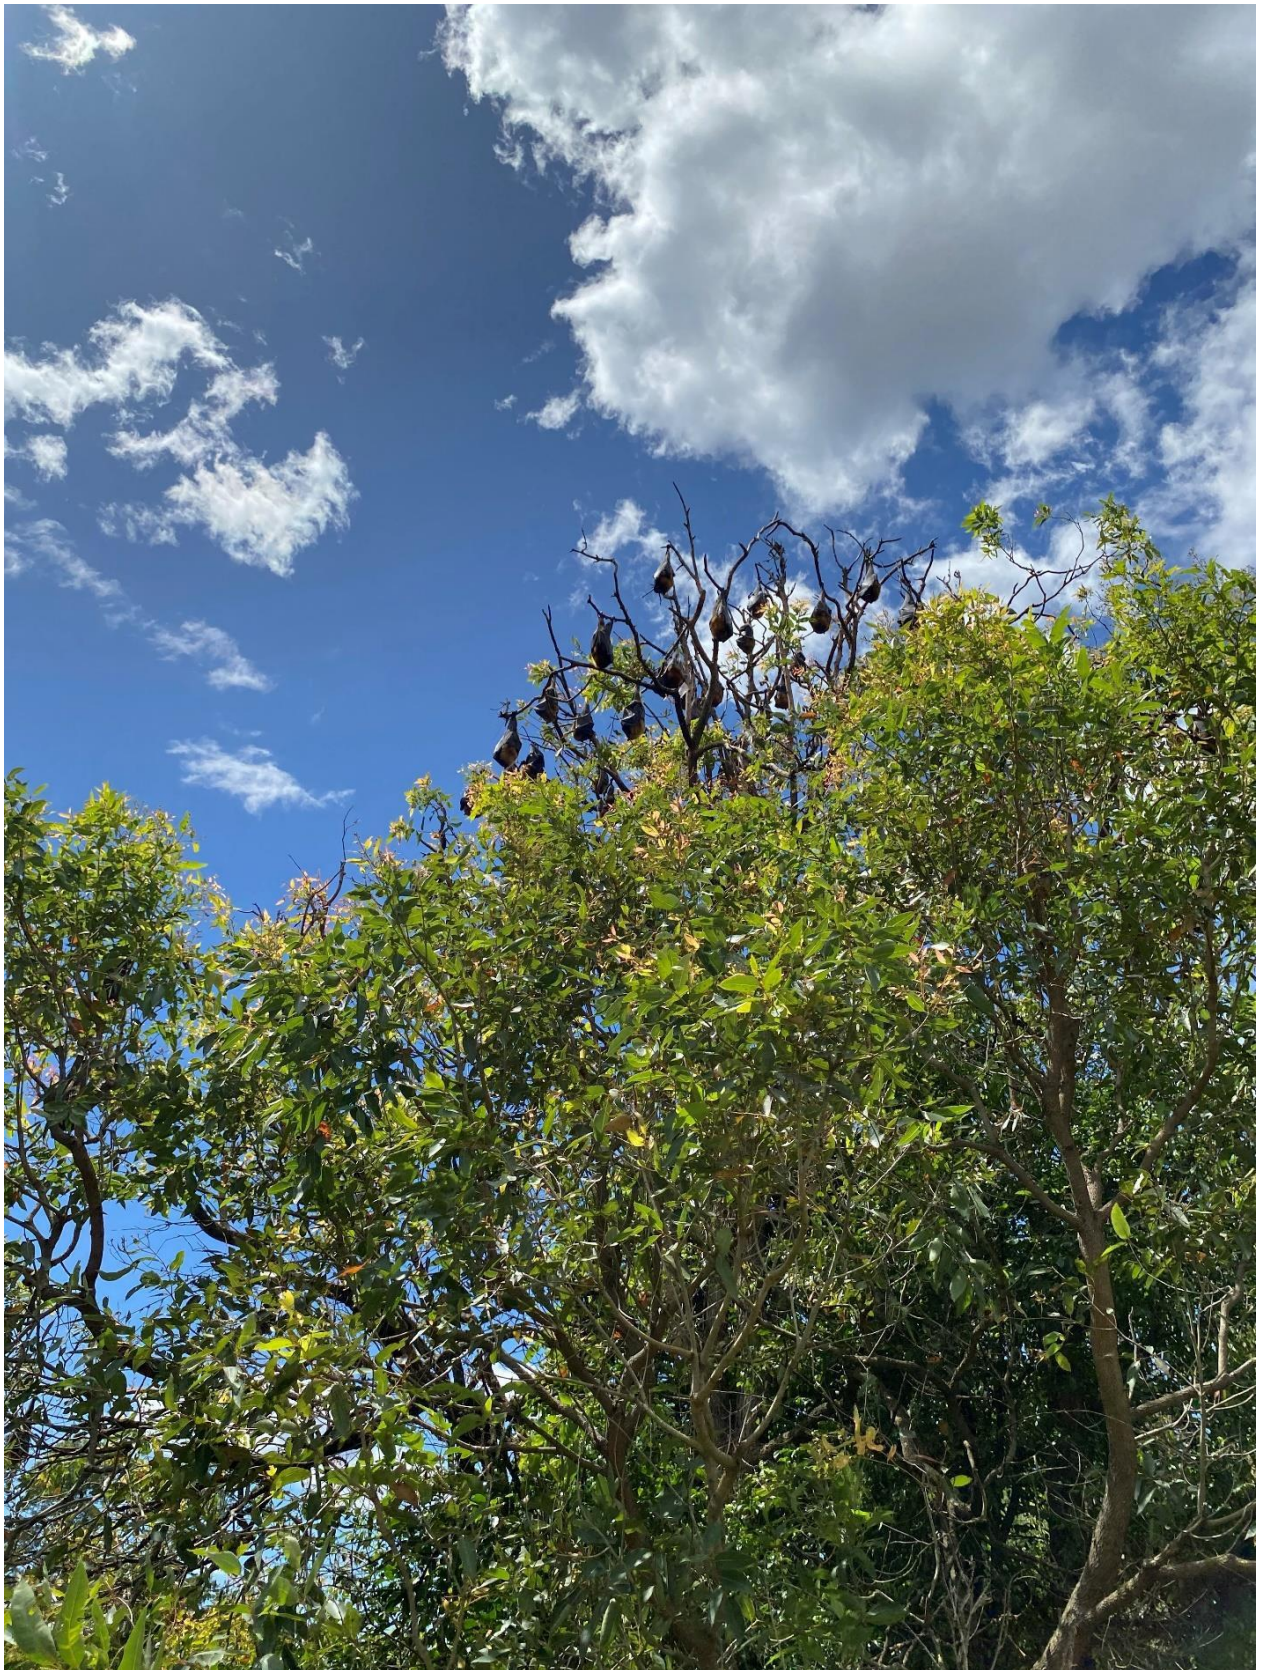
Figure 4: Flying-foxes roosting during session. Very little activity during session, approx. 10 flying-foxes returned. Photo taken at 10:57.
